September 4, 2019

Subject: **Report of Product Testing**
Product: Pile Comparison Testing
TEC Services Project No. TEC 11-0873
TEC Lab ID: 19-1073

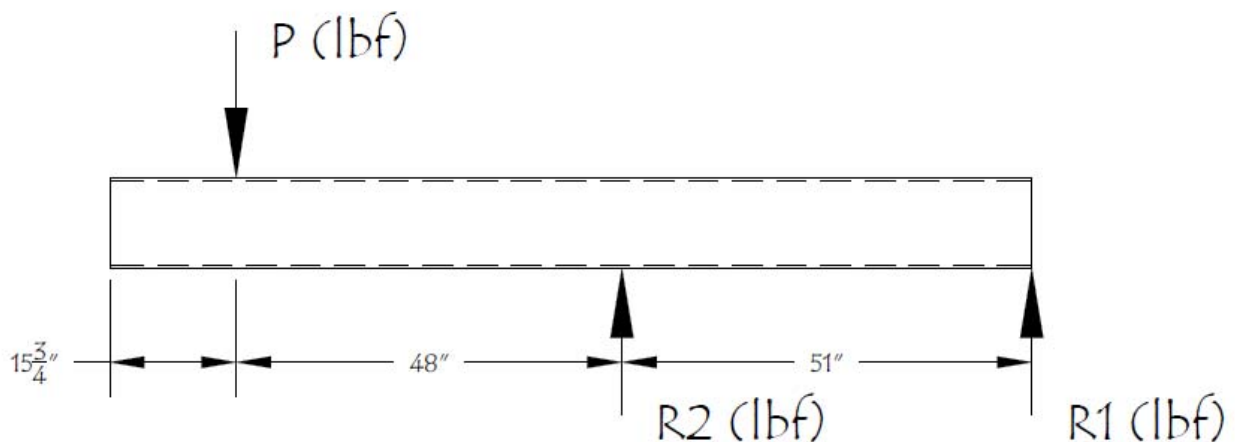
Figure 1 – Loading Diagram

Four 10ft tube sections from each manufacturer were tested in a cantilever arm loading configuration in a similar fashion to the actual intended use of the products for boat dock anchorage. Photos of the testing configuration and schematic for the location of the applied load are attached to this report. Each piling was mounted in the test machine in the same manner to ensure that the spacing of the load and reaction points were kept constant. Dimensional measurements for each pile were also made prior to the start of testing which included the wall thickness and outer diameter. Load was measured using a 50,000 lbf. load cell. Measurements for displacement were determined using an instrument grade string potentiostat transducer mounted on the underside of the pile at the point of load application. The data acquisition rate was 1 Hz for the entire duration of each test. Specimens were loaded until failure. Summary test results are reported in Table 1. Complete test results are reported in Table 2. Figures of Load vs. Displacement are shown in Figures 2-7. Select photo of testing are shown in Photos 1-5.

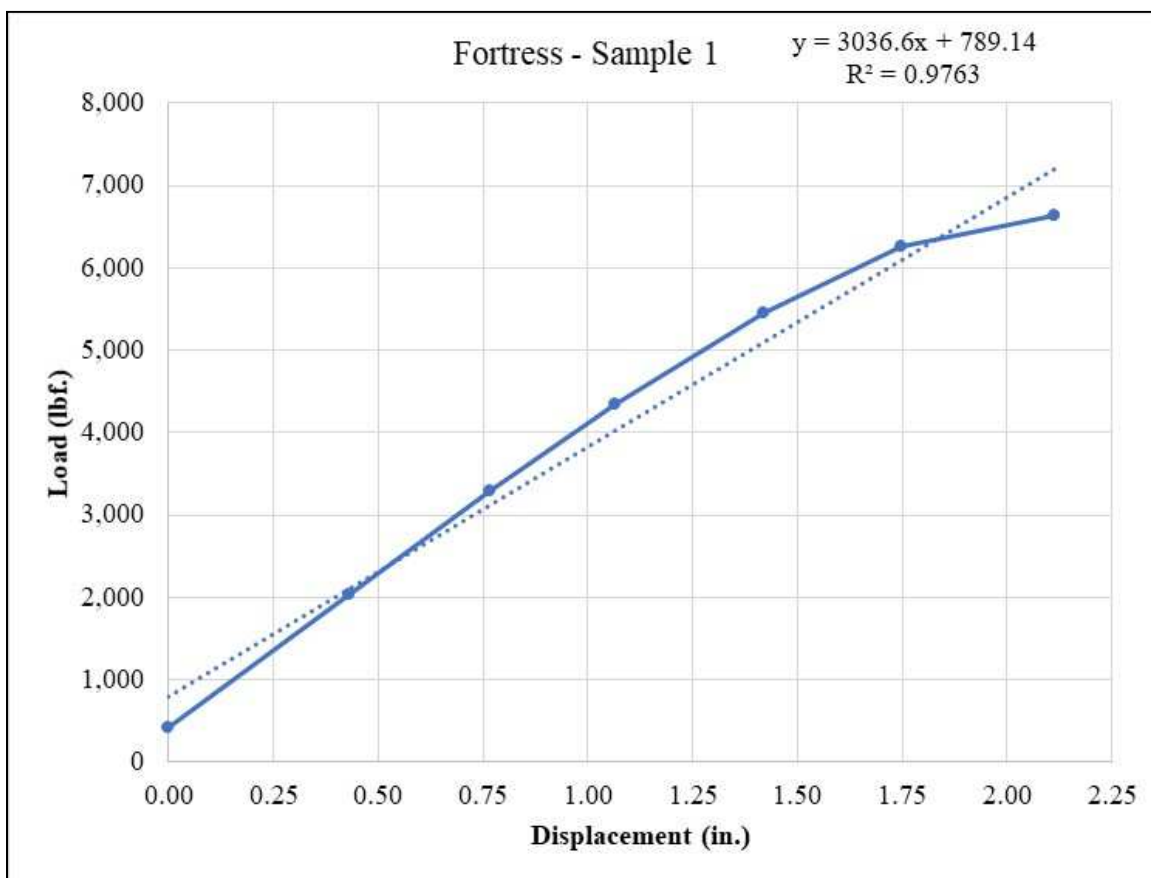
Figure 2 – Load vs. Displacement

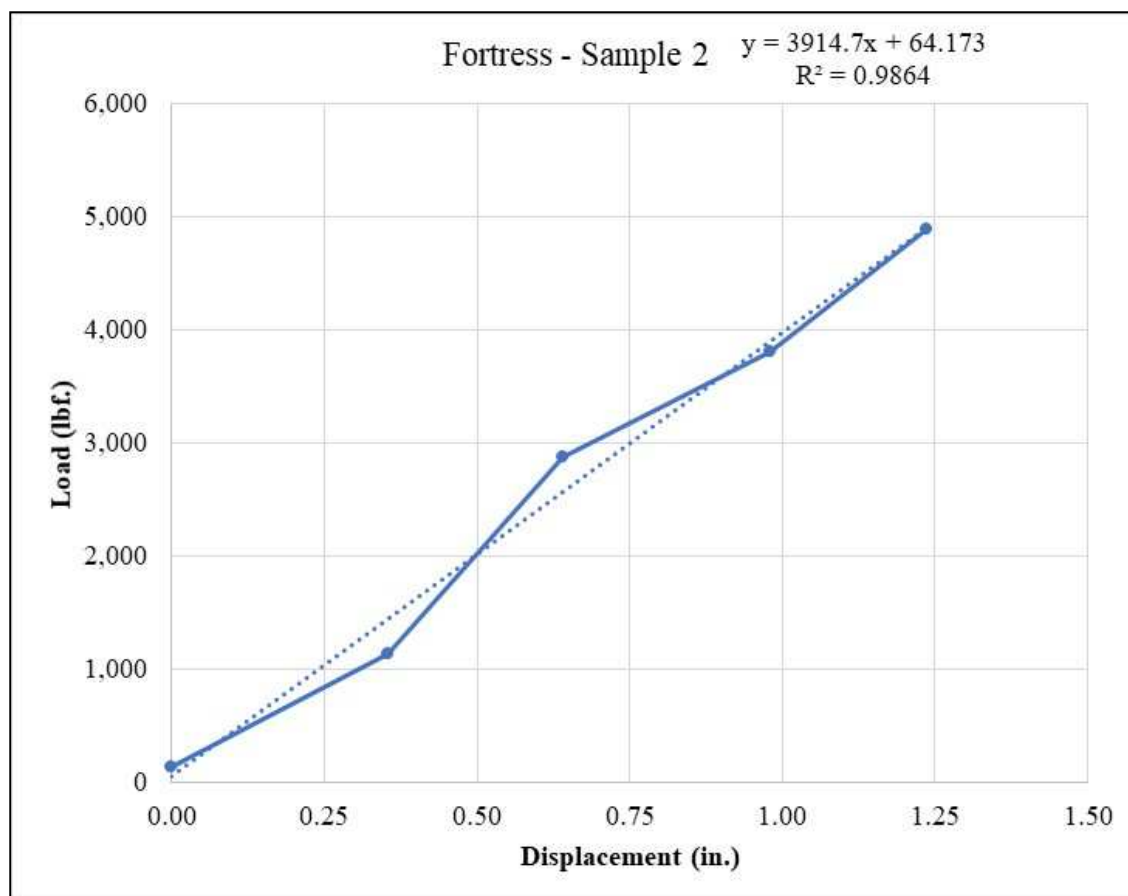
Figure 3 – Load vs. Displacement

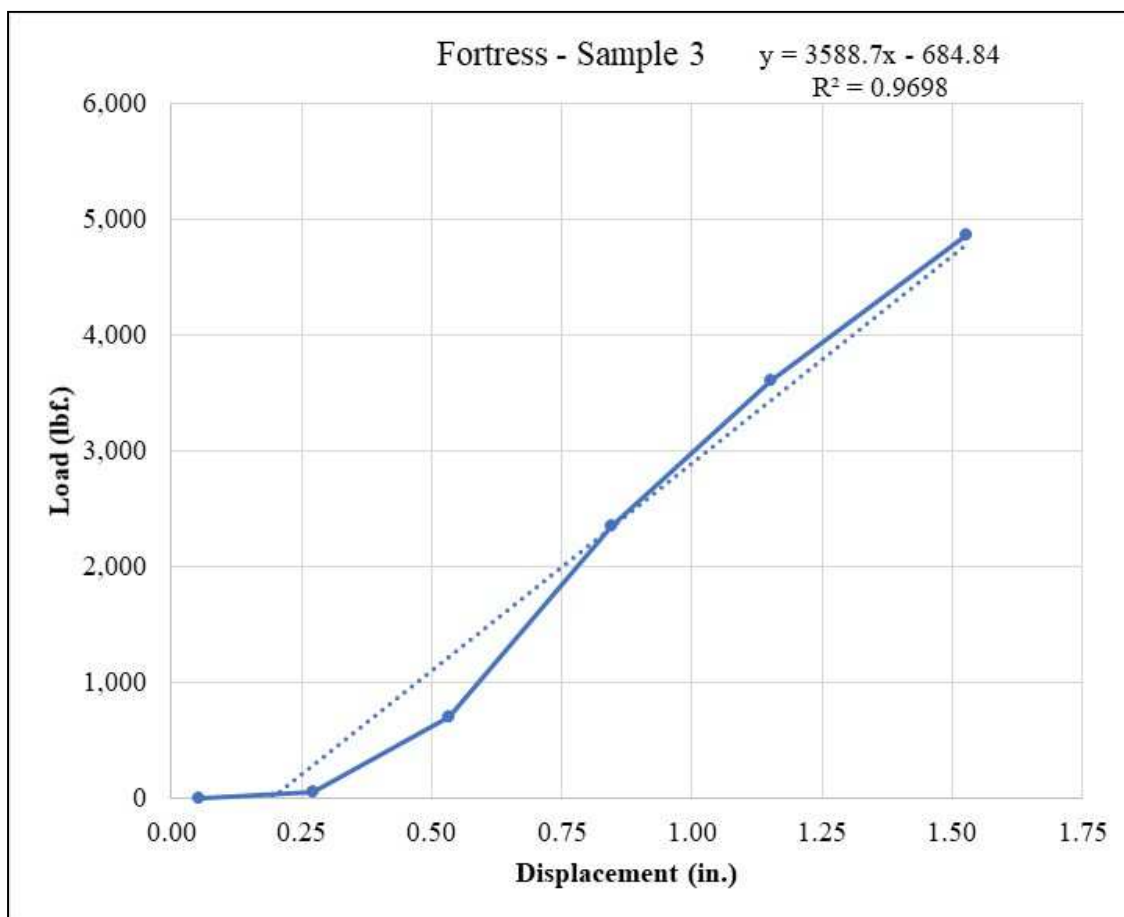
Figure 4 - Load vs. Displacement

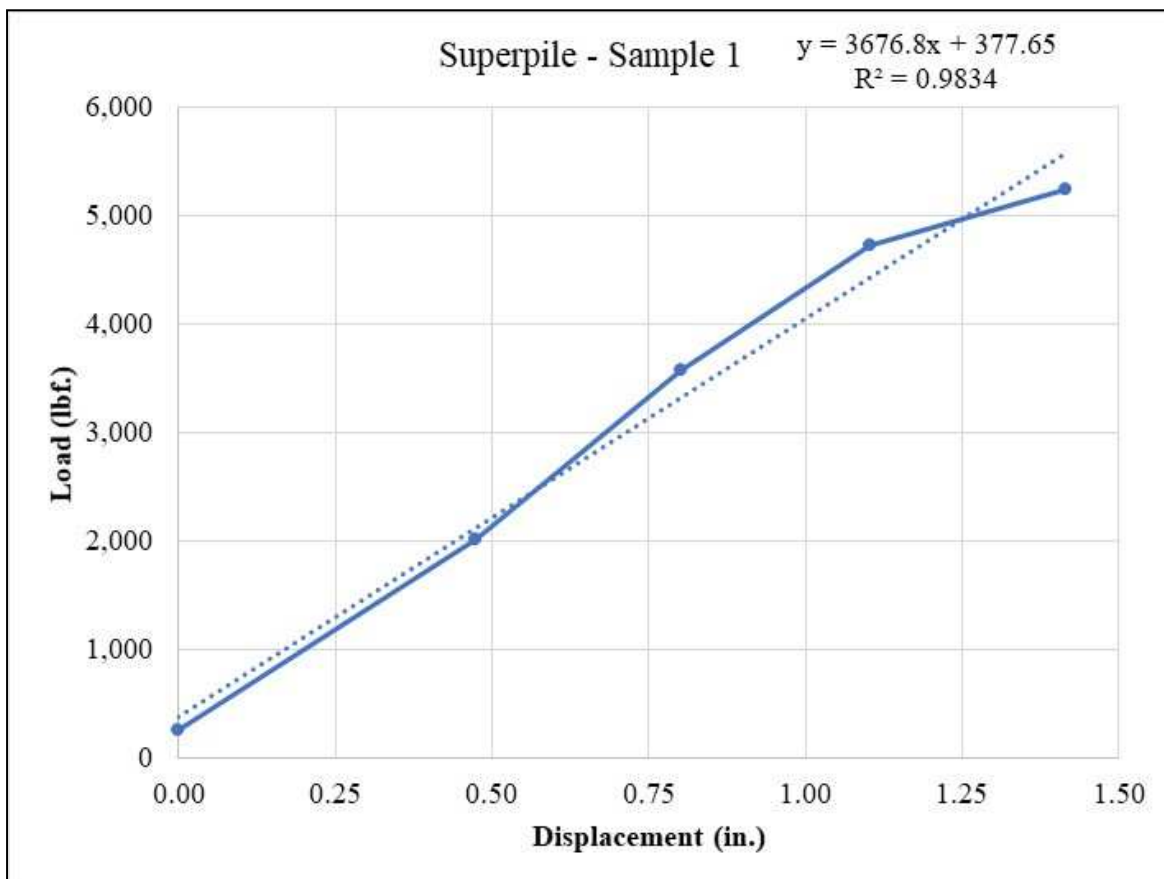
Figure 5 - Load vs. Displacement

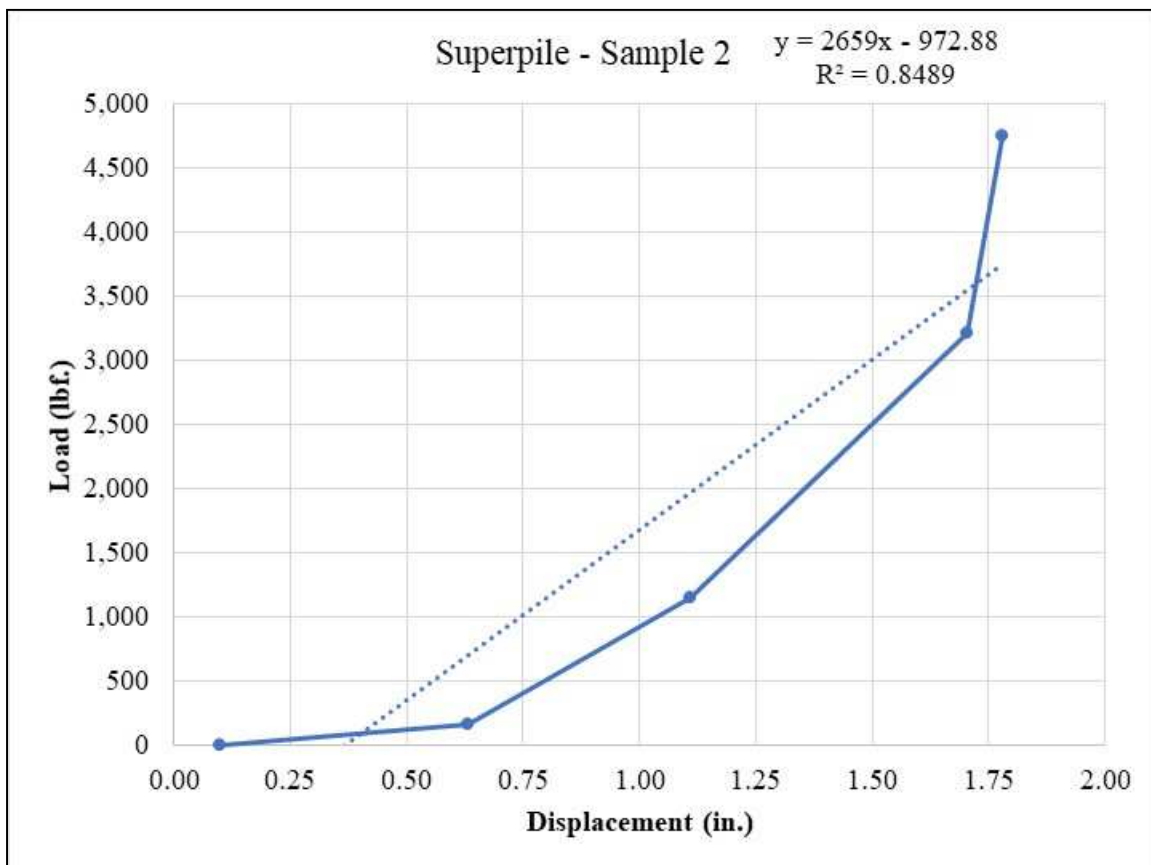
Figure 6 - Load vs. Displacement

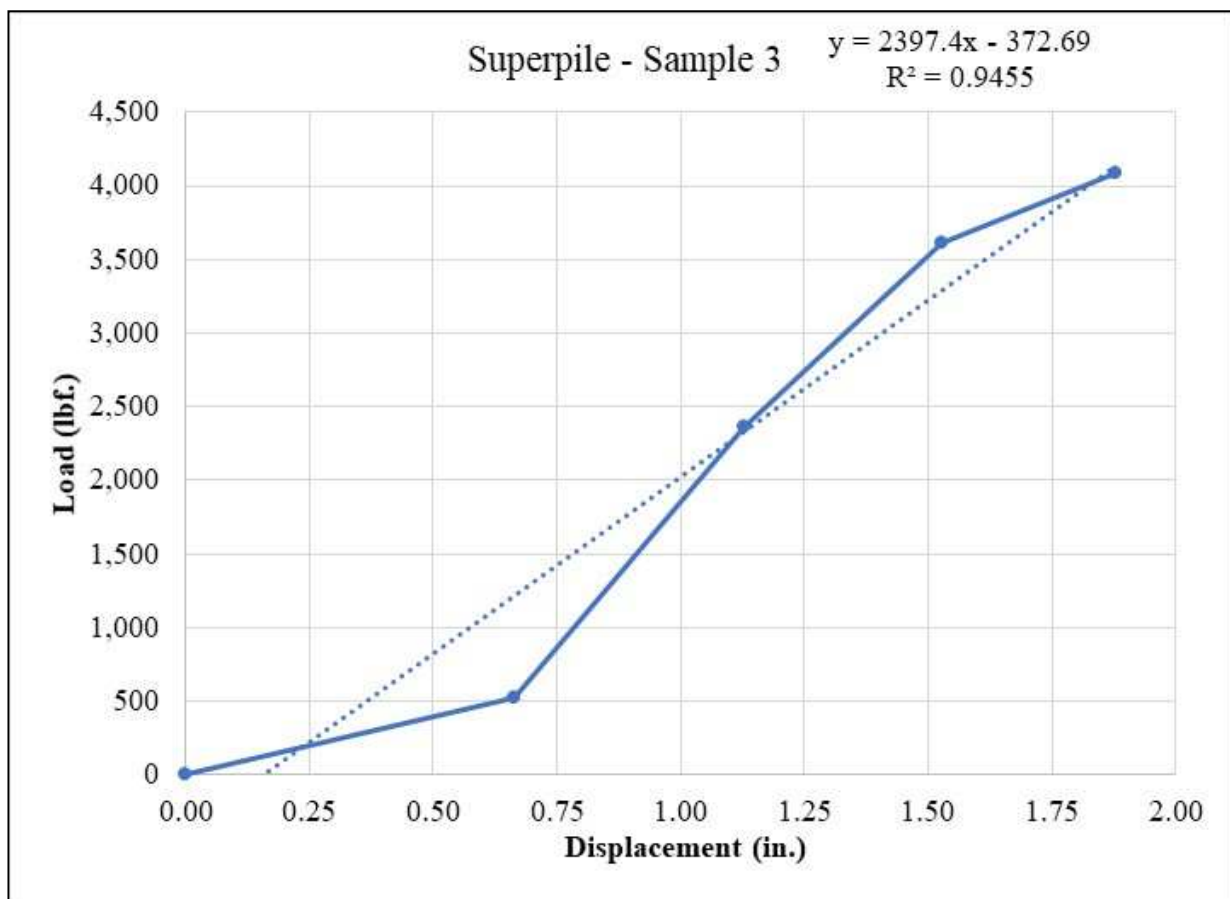
Figure 7 - Load vs. Displacement

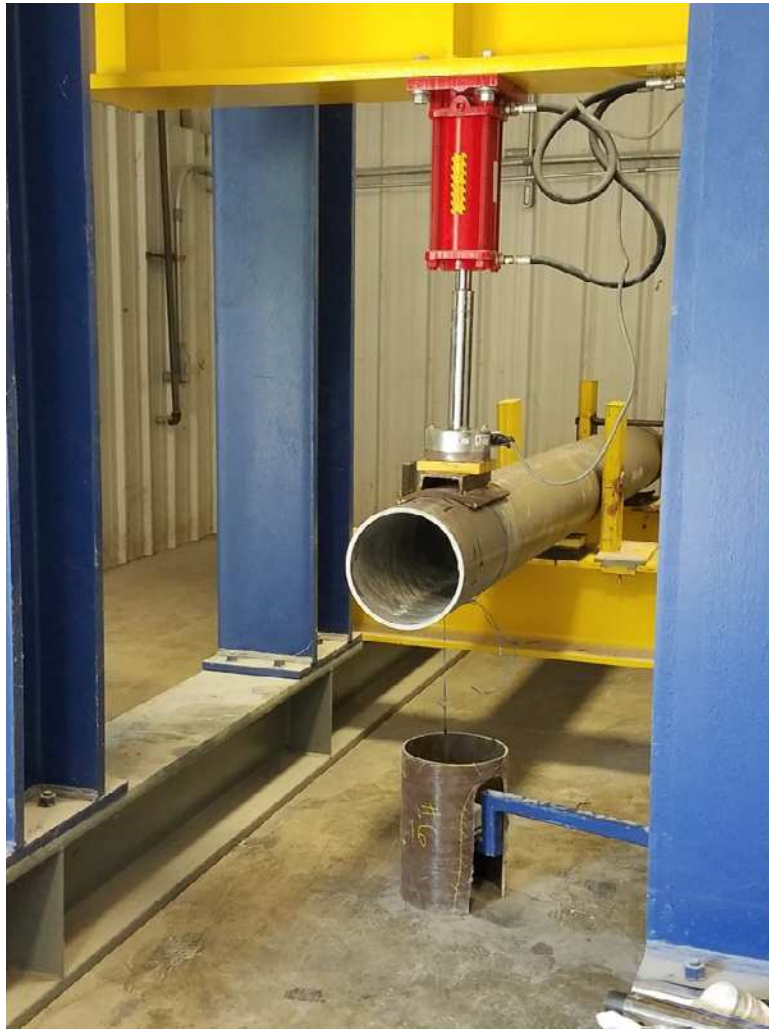
Photo 1 – Test Setup

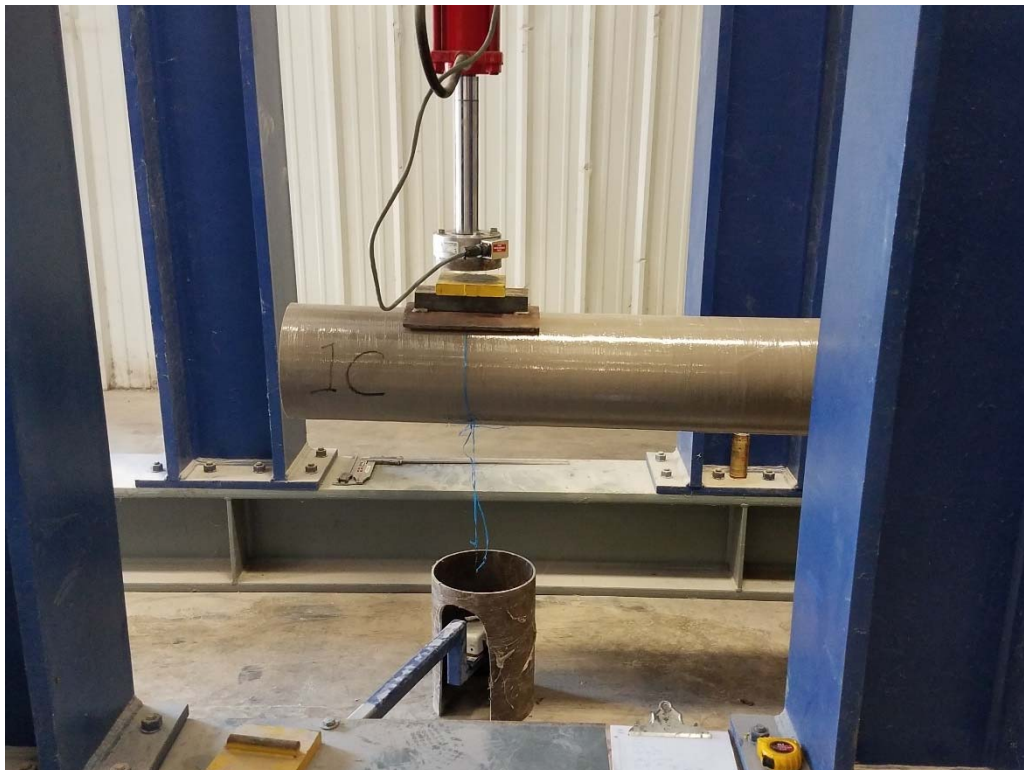
Photo 2 – Test Setup – Side View

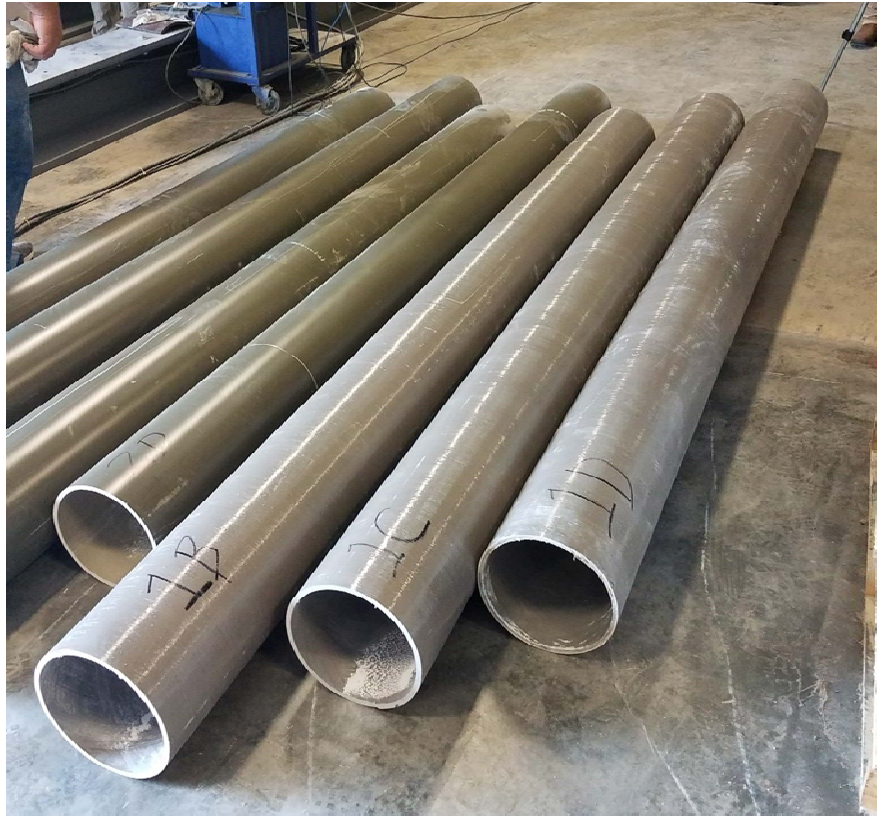
Photo 3 – Test Samples

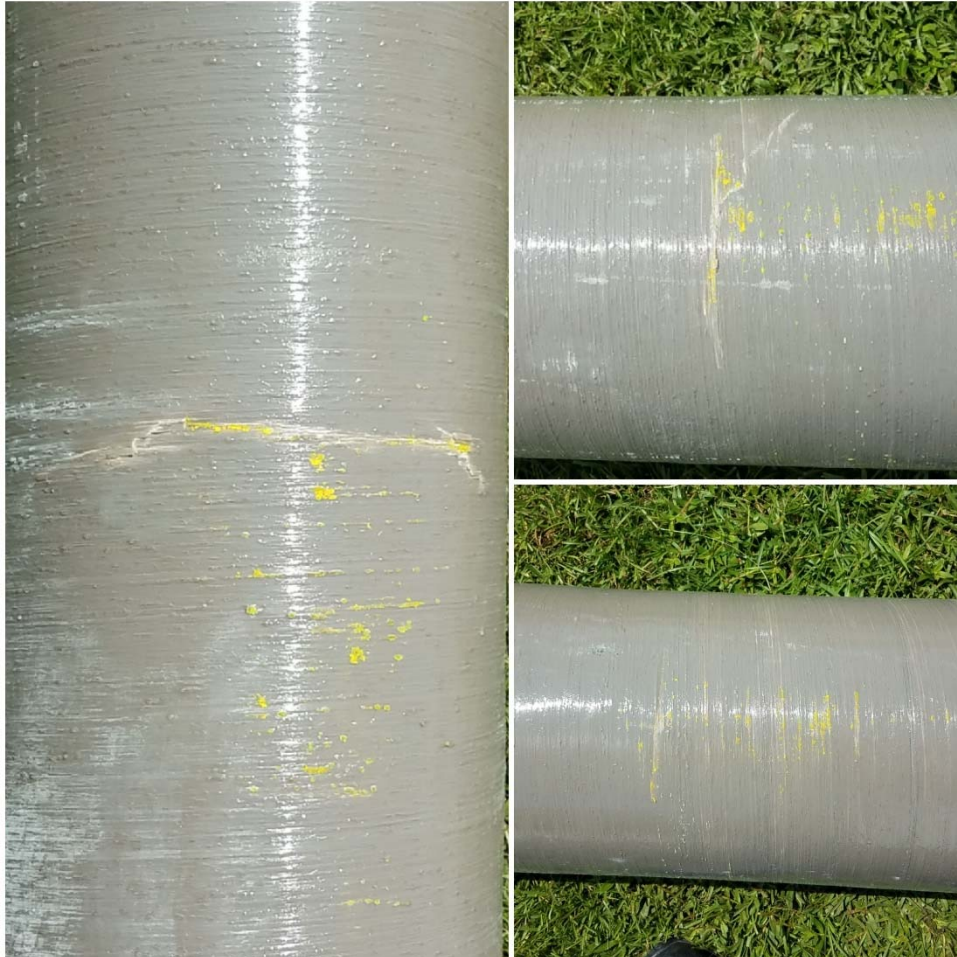
Photo 4 – Typical Failure of Fortress Pilings – Single Lateral Crack at Reaction #2

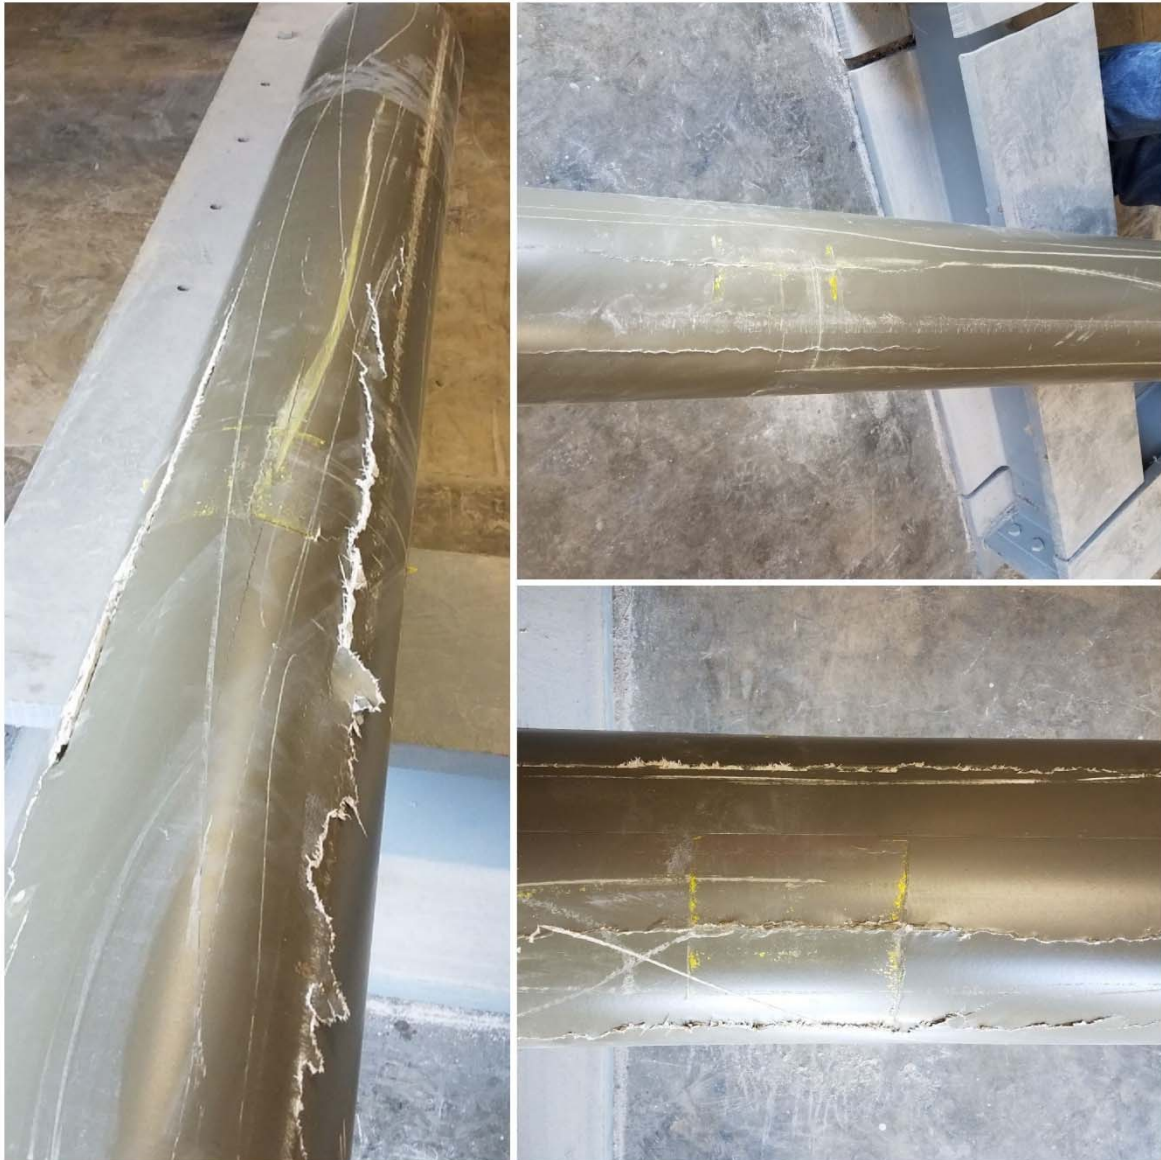
Photo 5 – Typical Failure of Superpile – Longitudinal Cracking from P to Reaction #2
